Cedar Lake, a privately owned, man made lake in central Oklahoma mysteriously failed November 7, 1986. The 75 acre lake, 30 feet deep at the dam, dropped 15 feet within a 36 hour period. Water exited the ground 250 yards downstream of the earth fill dam leaving the embankment intact.

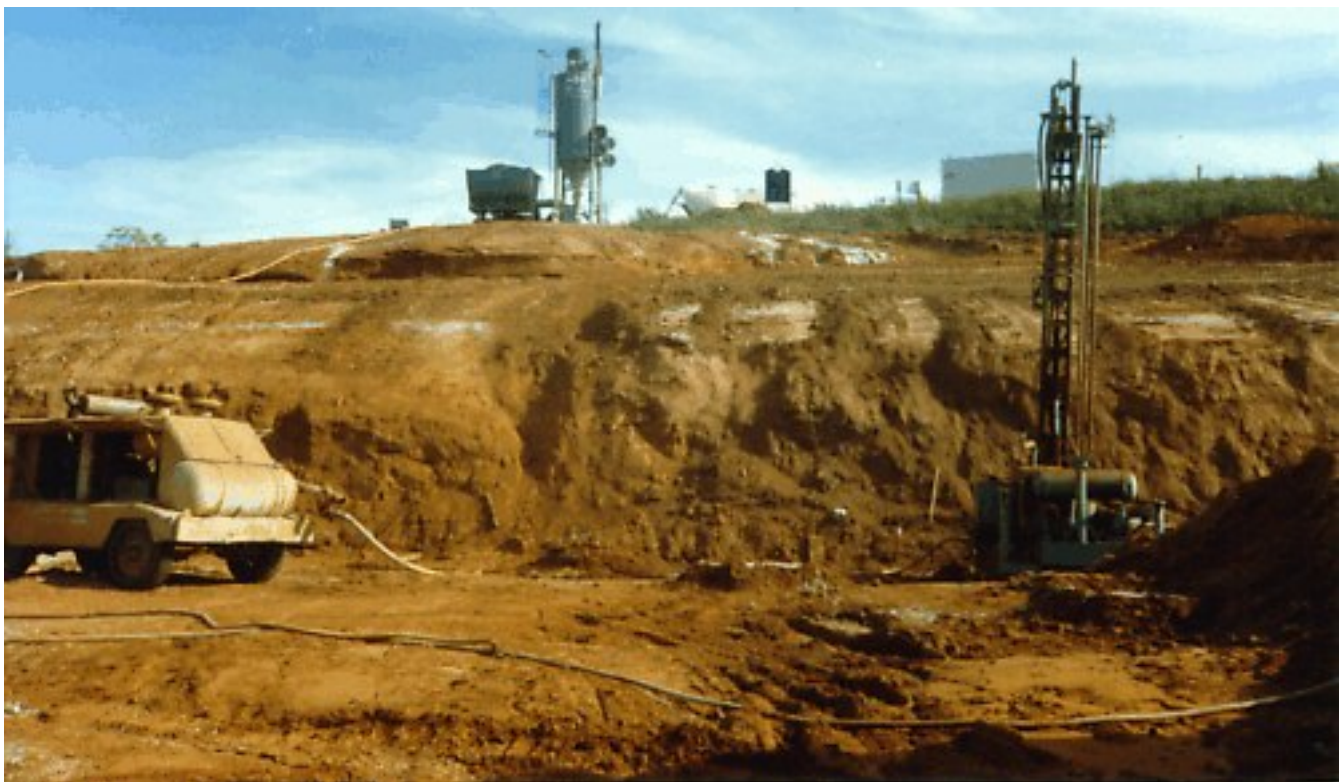
The dam was located in the lower section of a highly fractured, loosely cemented sandstone formation. The most likely cause for the failure was creation of a communication route between the preexisting fractures and the waterbearing sandstone reservoir below the lake bed.

Western Sportsmen Club, owner of the dam, awarded a \$456,000 contract to The Judy Company to repair the dam. Repairs included enlarging the breached section of the dam, performing drilling and consolidation grouting, and construction of a grout cutoff wall.

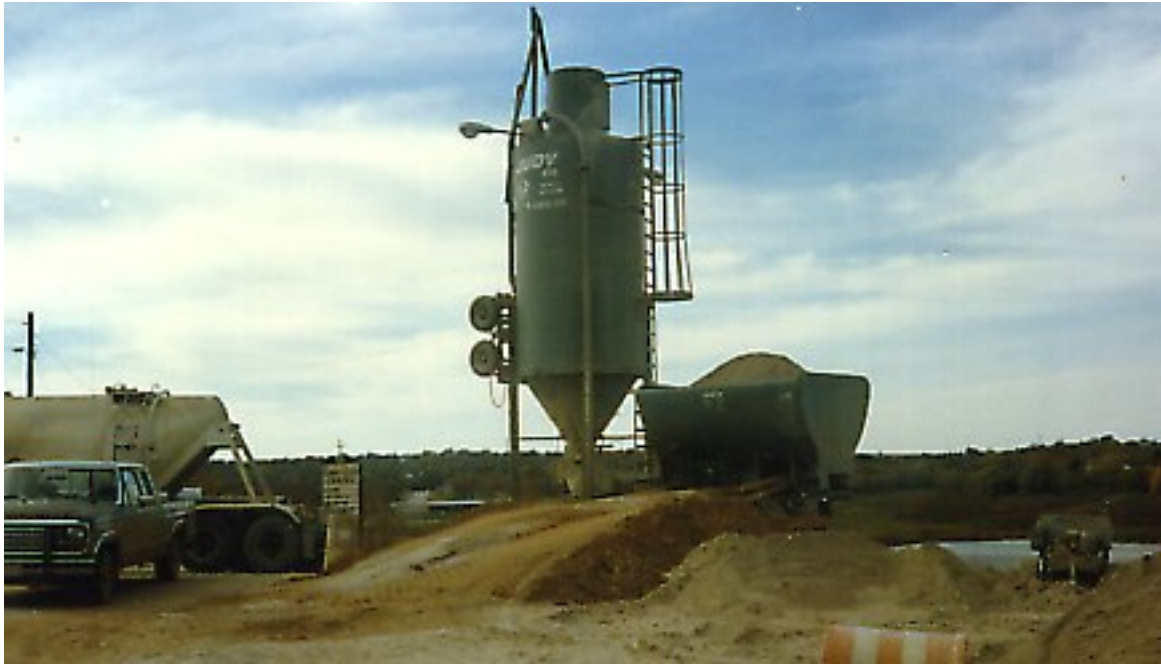
No significant voids were encountered where the failure was suspected. Drilling continued along the right abutment where voids from 2 to 3 feet were located above the unconsolidated zone. Voids as much as six feet were subsequently encountered up to 215 feet away from where the failure was suspected.

891 C.Y. of sand/fly ash consolidated fill and 250 C.Y. of cement pressure grout were placed. Four piezometers were installed at the downstream toe to continue monitoring the groundwater level as the lake filled.
